# **INDOOR AIR QUALITY ASSESSMENT**

**Dean Luce Elementary School  
45 Independence Street  
Canton, Massachusetts**

Prepared by:  
Massachusetts Department of Public Health  
Bureau of Environmental Health  
Indoor Air Quality Program  
February 2008

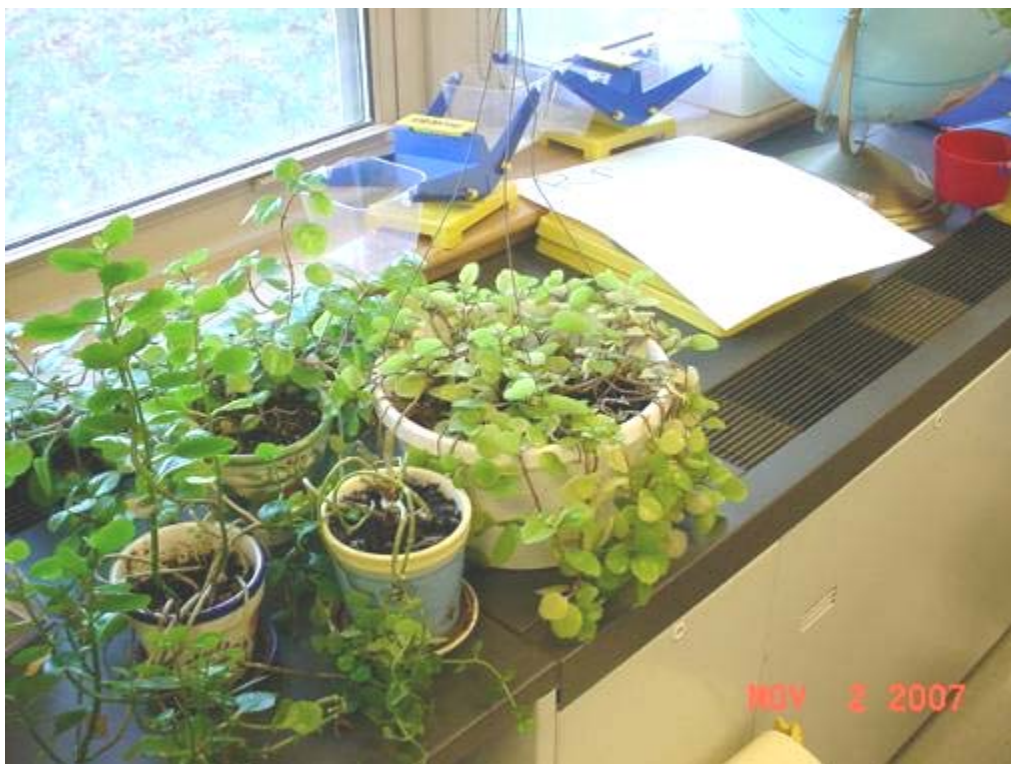
**Picture 1**

Several classrooms had a number of plants. Moistened plant soil and drip pans can be a source of mold growth. Plants should be equipped with drip pans; the lack of drip pans can lead to water pooling and mold growth on windowsills. Plants are also a source of pollen. Plants should be located away from the air stream of ventilation sources to prevent the aerosolization of mold, pollen or particulate matter throughout the classroom (Picture 1).

**Classroom Univent, Note Plants Near Air Diffuser**

11. Move plants away from univents in classrooms. Avoid over-watering and examine drip pans periodically for mold growth. Disinfect with an appropriate antimicrobial where necessary.

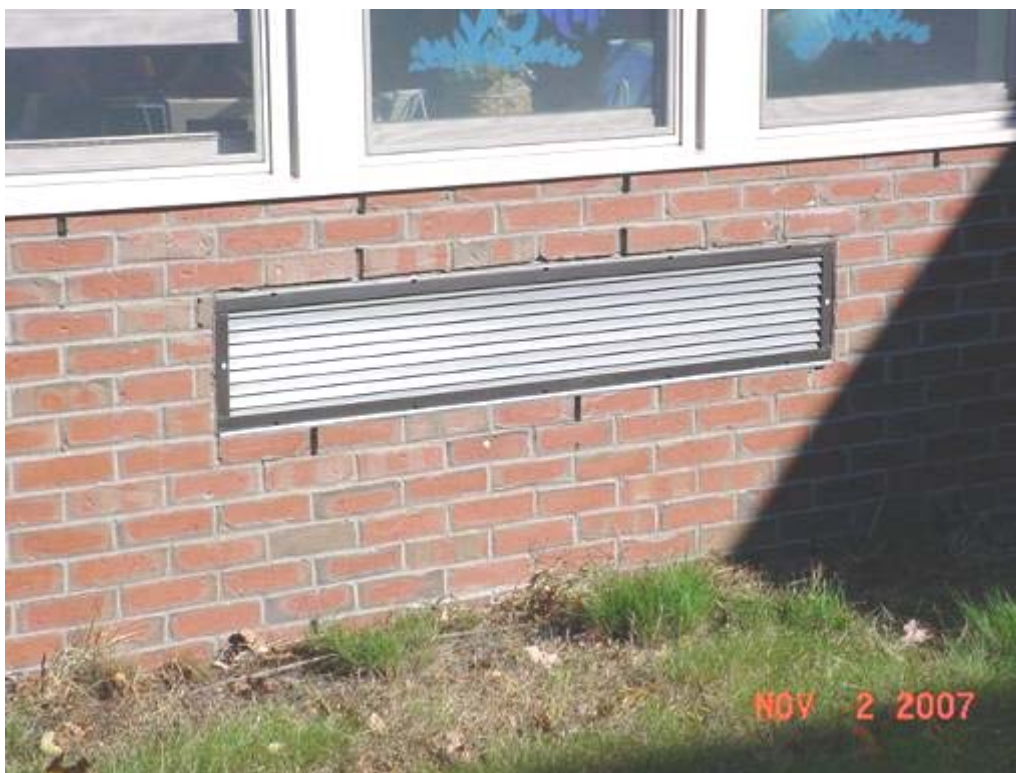
**Picture 2**

**Univent Fresh Air Intake Vent**

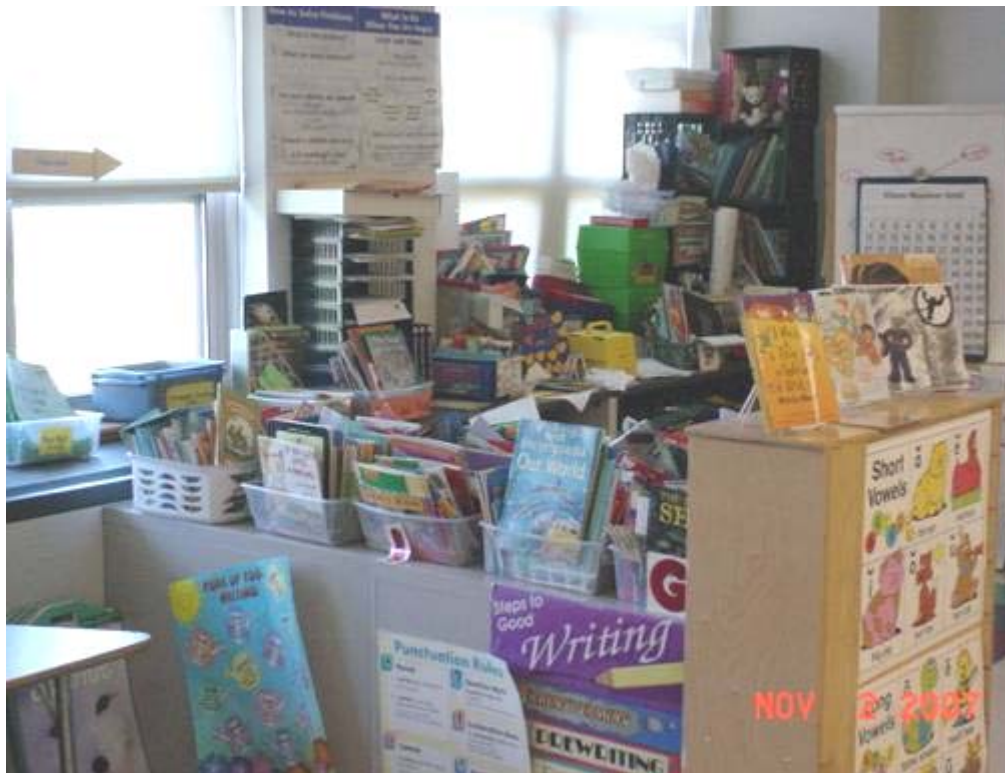
**Picture 3**

[1](#)). Fresh and return air are mixed, filtered, heated and provided to classrooms through an air diffuser located in the top of the unit. In a number of classrooms, items placed on and/or in front of univents and exhaust vents obstructed normal airflow (Picture 3).

**Accumulated Classroom Items Obstructing Univent Return Vent (Bottom Front of Unit)**

2. Remove all blockages from univents and exhaust cubbies to ensure adequate airflow.
3. Close classroom doors to maximize air exchange.
4. Consider adopting a balancing schedule of every 5 years for all mechanical ventilation systems, as recommended by ventilation industrial standards (SMACNA, 1994).

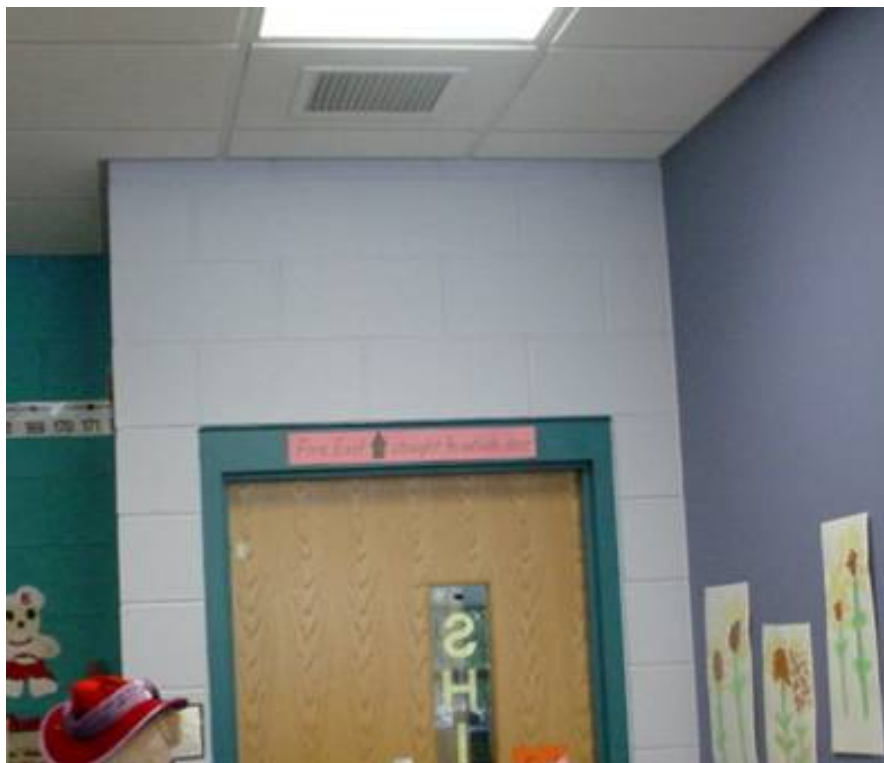
**Picture 4**

Exhaust ventilation for classrooms in the 1999 addition is provided by ceiling vents ducted to rooftop motors (Pictures 4 and 5). The location of some exhaust vents (i.e. above hallway door) can limit exhaust efficiency (Picture 4). When a classroom door is open, exhaust vents tend to draw air from both the hallway and the classroom. The open hallway door reduces the effectiveness of the exhaust vent to remove common environmental pollutants from classrooms. Exhaust vents in the 1954 wing are located in floor level “cubbies” ducted to rooftop motors. Many of the exhaust cubbies were obstructed and/or being used for storage of items, limiting airflow (Pictures 6 and 7). Without exhaust ventilation, normally occurring environmental pollutants can build up, leading to indoor air complaints.

**1999 Addition Classroom Exhaust Vent, Note Proximity to Hallway Door**

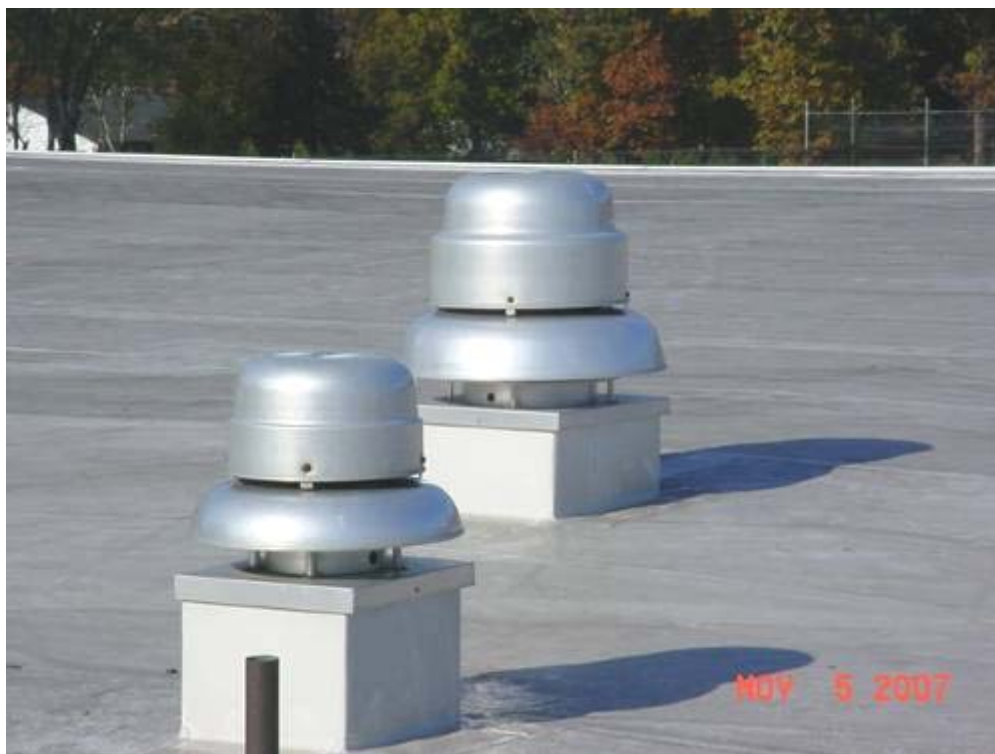
**Picture 5**

**Rooftop Exhaust Motors**

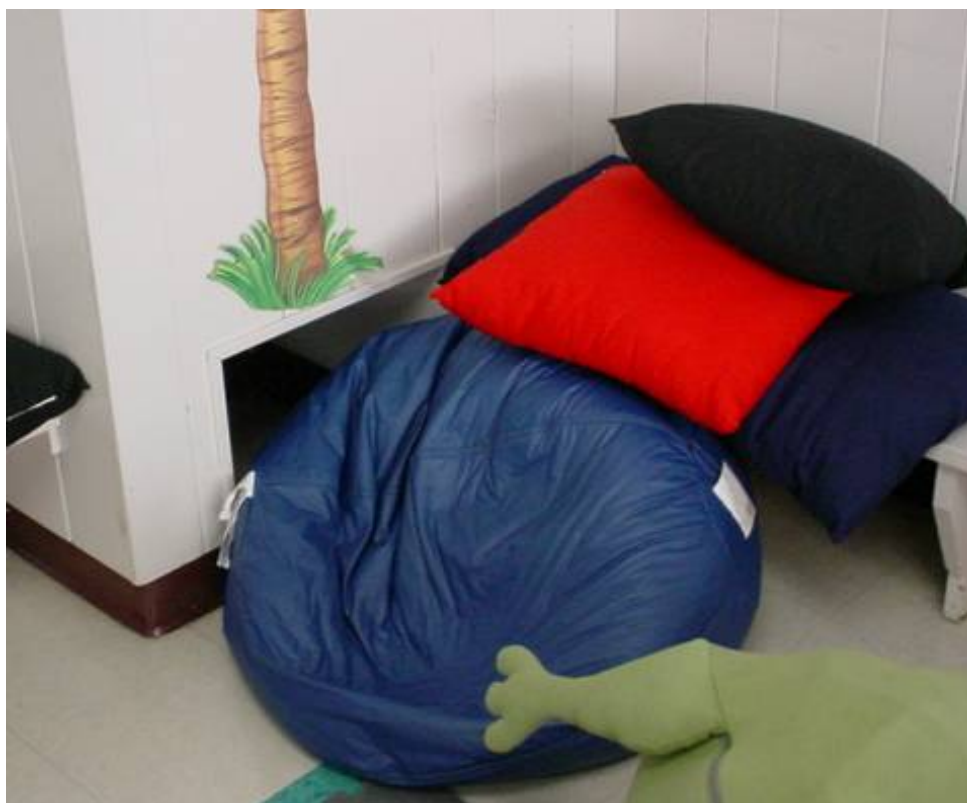
**Picture 6**

**Obstructed Exhaust "Cubby" in 1954 Wing**

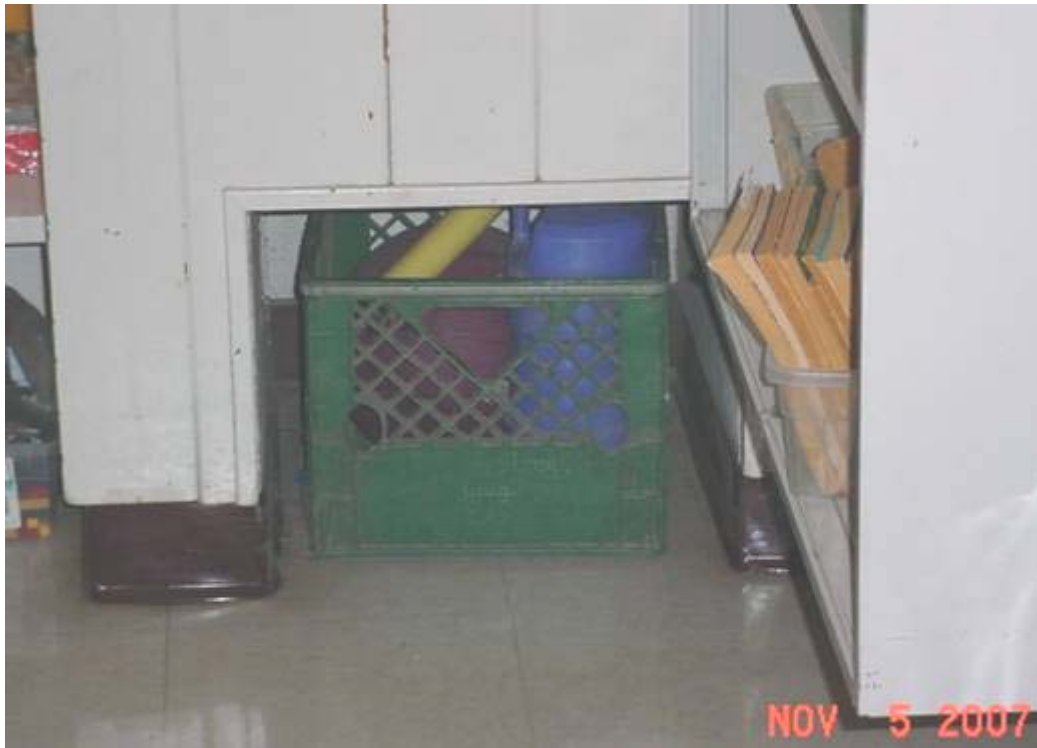
**Picture 7**

**Exhaust "Cubby" in 1954 Wing Used for Storage**

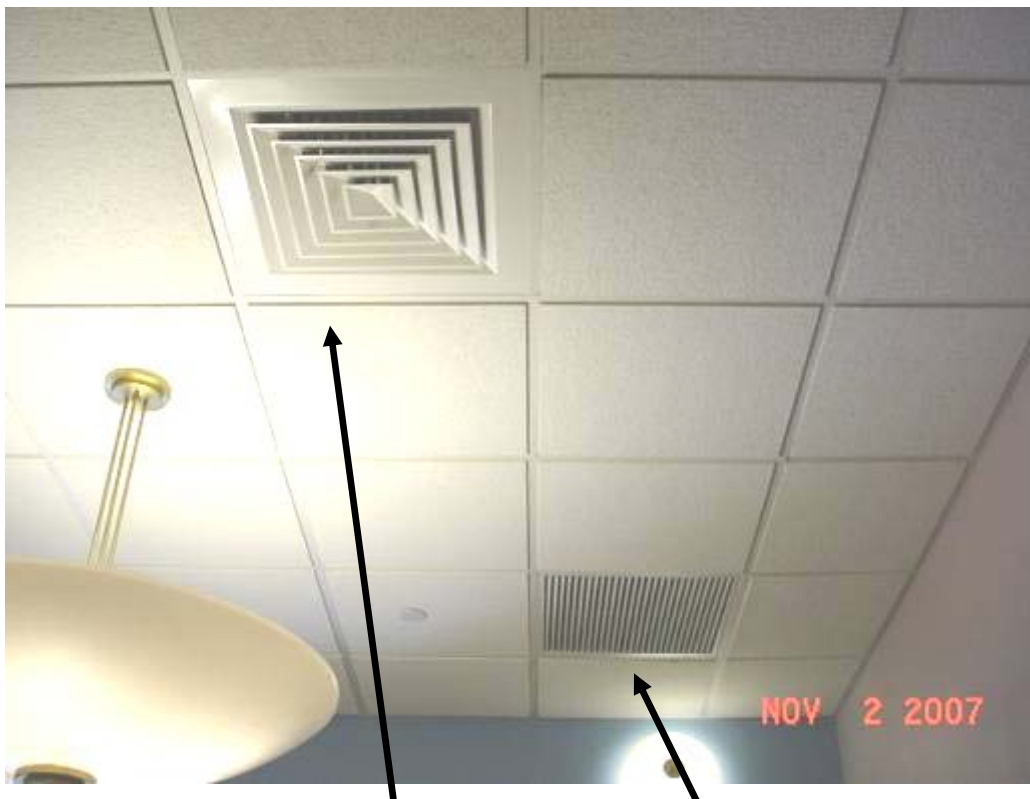
**Picture 8**

**Supply Air Diffuser and Return Vent**

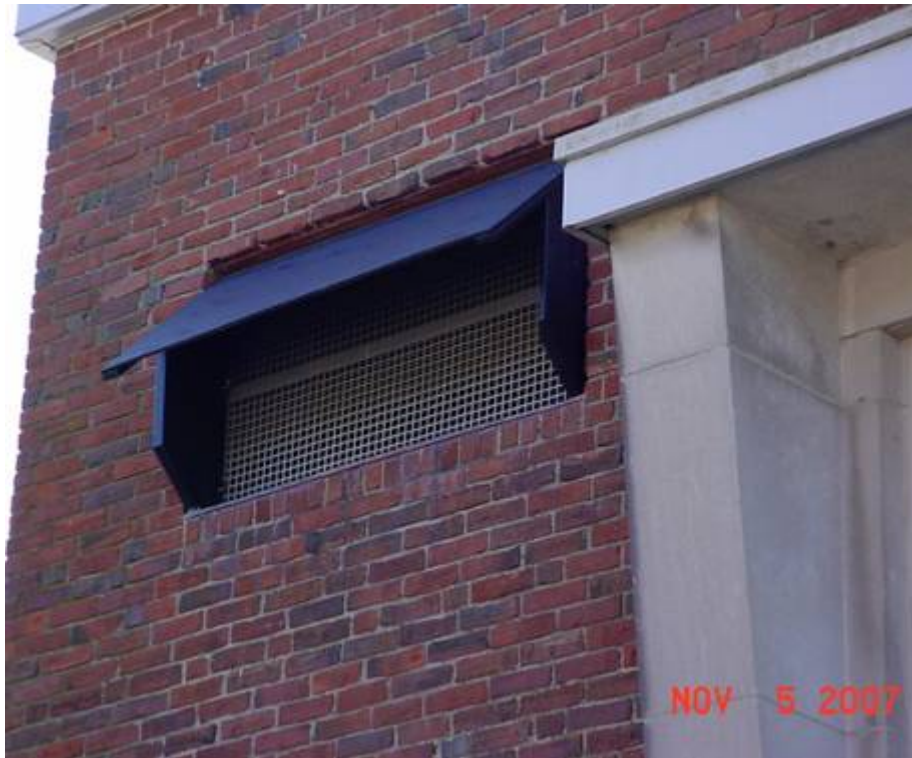
**Picture 9**

- The water damage experienced previously in the library hallway was due to water penetration around a ducted vent on the exterior wall of the building. To mitigate water penetration into the building, Canton School Department (CSD) maintenance staff installed a rain/wind shield around the vent (Picture 9). No current water damage or mold growth was observed above the ceiling in this area.

**Rain/Wind Shield Installed over Vent Outside of Library Hallway**

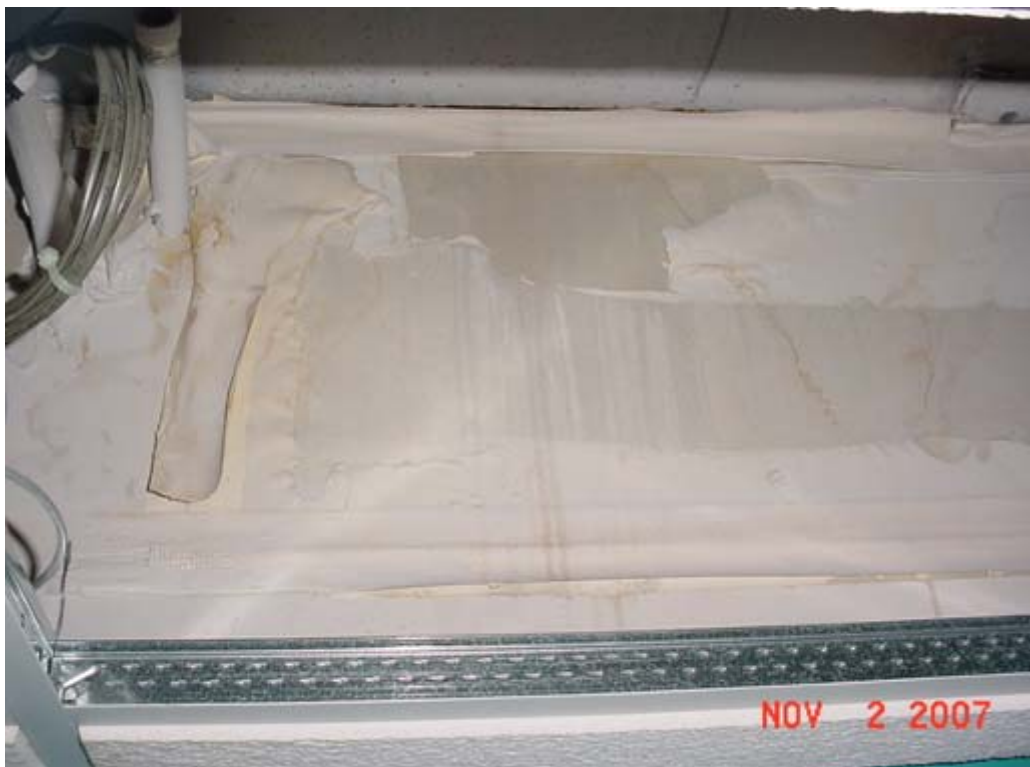
**Picture 10**

- In classroom 75, evidence of water penetration was found in the form of stained GW along the ceiling and above the ceiling tiles (Picture 10). On November 2, 2007, the GW above the ceiling tile system was found to have low (i.e., normal) moisture content. It was reported by school maintenance staff that leaks were experienced in this area from water penetration along a joint where the lower roof of the 1999 wing meets the gymnasium exterior wall (Picture 11). This area was reportedly resealed to prevent further water damage. On November 5, 2007, the GW had an elevated moisture content indicating that despite efforts to eliminate leaks, water continues to penetrate into this area. BEH staff recommended to Mr. Cotto that the moistened GW be removed to prevent mold growth and that CSD work with their roofing contractor to determine potential pathways for water penetration. During a November 28, 2007 conversation, Mr. Cotto reported this GW was removed.

**Water Damaged GW above Ceiling in Room 75**

6. Continue working with building maintenance staff and roofing contractor to investigate/monitor leak causing damage in room 75 (e.g., roof/gym wall junction), make repairs as needed.

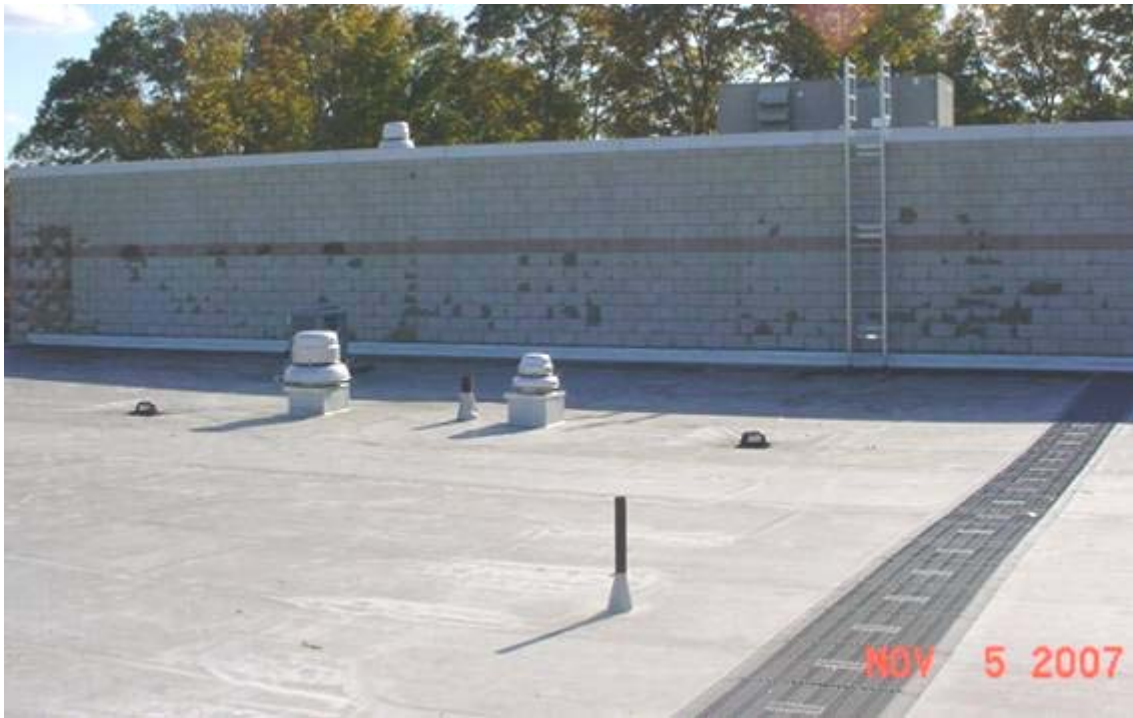
**Picture 11**

**Junction/Seam along 1999 Wing Roof and Gymnasium Wall**

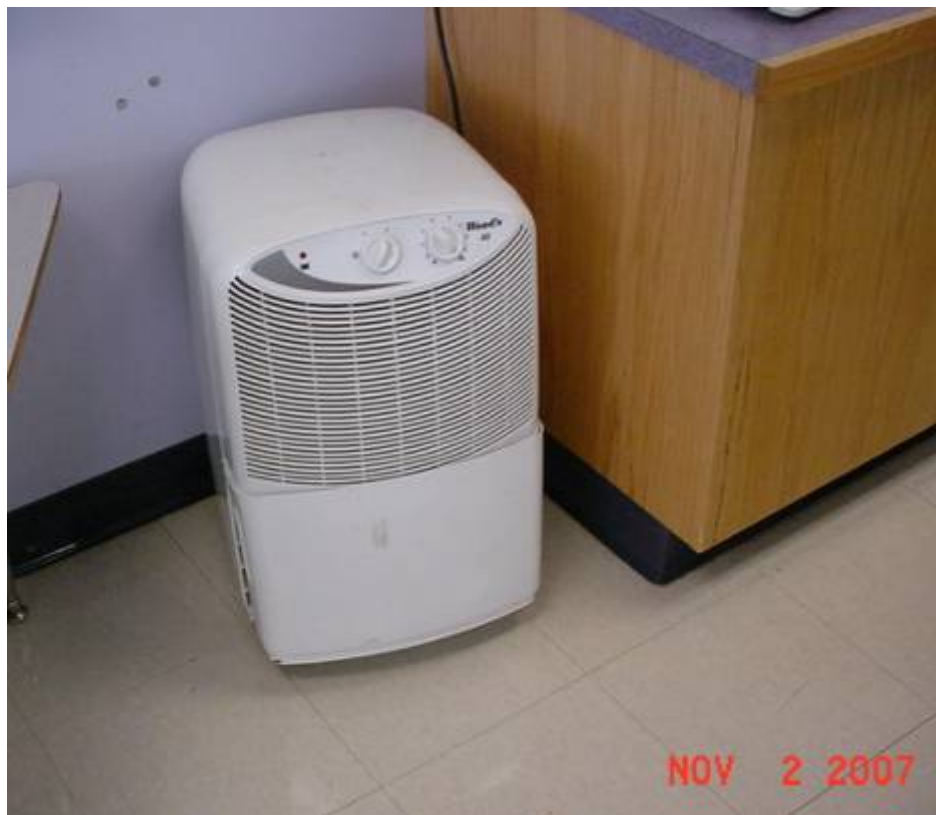
**Picture 12**

CSD staff reported that the building experiences problems with condensation during periods of elevated relative humidity (>70%). Introduction of uncontrolled hot, moist air via univents and/or windows likely generates condensation on chilled non-porous surfaces (e.g., floor tiles, windows). In order to decrease humidity in classrooms, floor model portable dehumidifiers are utilized (Picture 12). Dehumidifiers should be cleaned/maintained as per the manufacturer's instructions to prevent mold/bacterial growth and associated odors.

**Floor Model Dehumidifier in Classroom**

9. Ensure dehumidifiers are cleaned/maintained as per the manufacturer's instructions to prevent mold/bacterial growth.
10. Consider stationing dehumidifiers on countertops so they drain directly into sinks to prevent overflow and reduce maintenance.

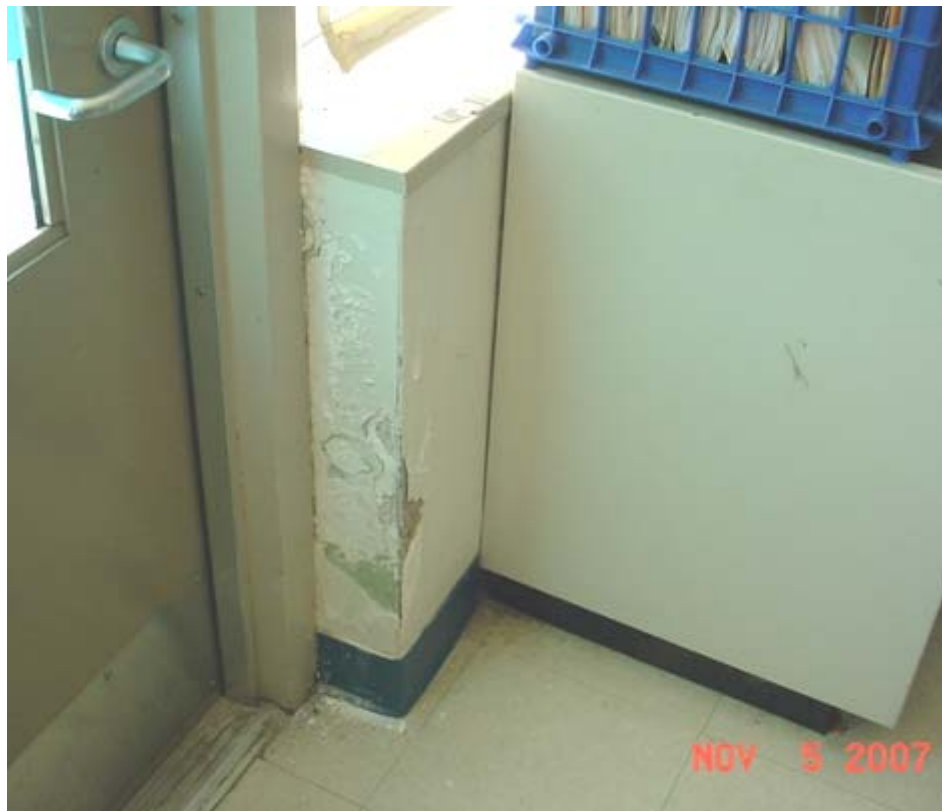
**Picture 13**

Water damaged wall plaster and peeling paint was observed below the windows near the exterior door in classroom 12 (Picture 13). It was reported that this damage was a result of previous water infiltration prior to windows being replaced during the 1999 renovation. At the time of the assessment no current water penetration was observed nor were elevated moisture readings measured.

**Water Damaged Wall Plaster and Peeling Paint in Classroom 12**

12. Make repairs to water damaged wall plaster near exterior door in classroom 12.
13. Relocate or consider reducing the amount of materials stored in classrooms to allow for more thorough cleaning of classrooms. Clean items regularly with a wet cloth or sponge to prevent excessive dust build-up.

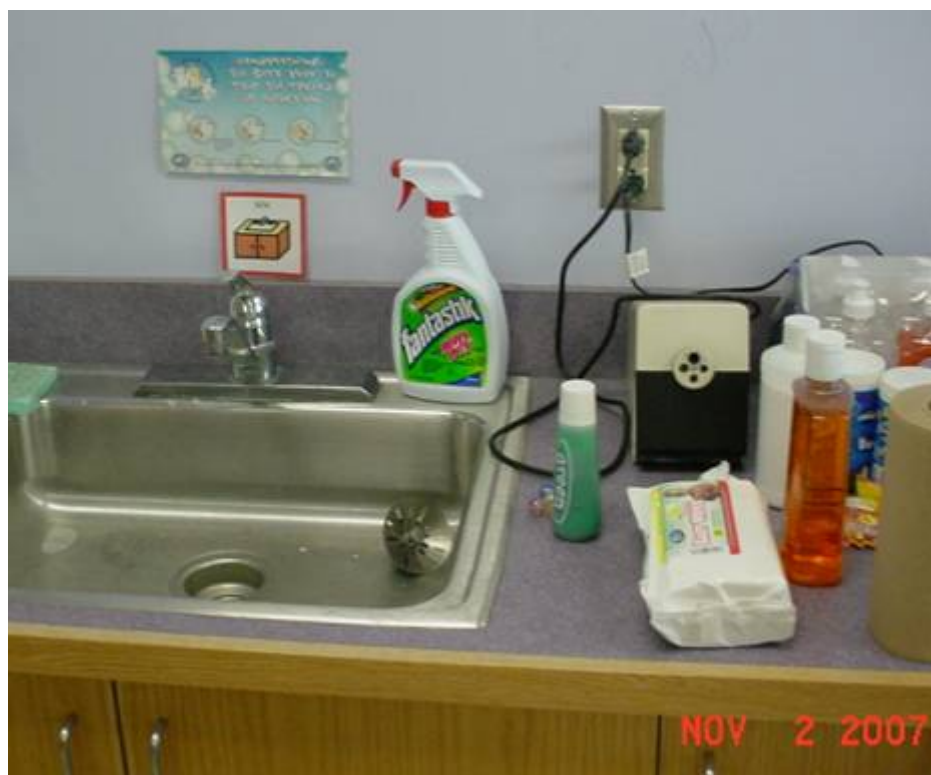
Picture 15

impacted by the use of TVOC containing products. In an effort to identify materials that can potentially increase indoor TVOC concentrations, BEH staff examined classrooms for products containing these respiratory irritants. Several classrooms contained dry erase boards and dry erase board markers. Materials such as dry erase markers and dry erase board cleaners may contain VOCs, such as methyl isobutyl ketone, n-butyl acetate and butyl-cellusolve (Sanford, 1999), which can be irritating to the eyes, nose and throat. Cleaning products were also found on countertops and in unlocked cabinets beneath sinks in some classrooms (Picture 15). Like dry erase materials, cleaning products contain VOCs and other chemicals that can be irritating to the eyes, nose and throat of sensitive individuals.

Spray Cleaning Products on Countertop in Classroom

18. Store cleaning products properly and out of reach of students.

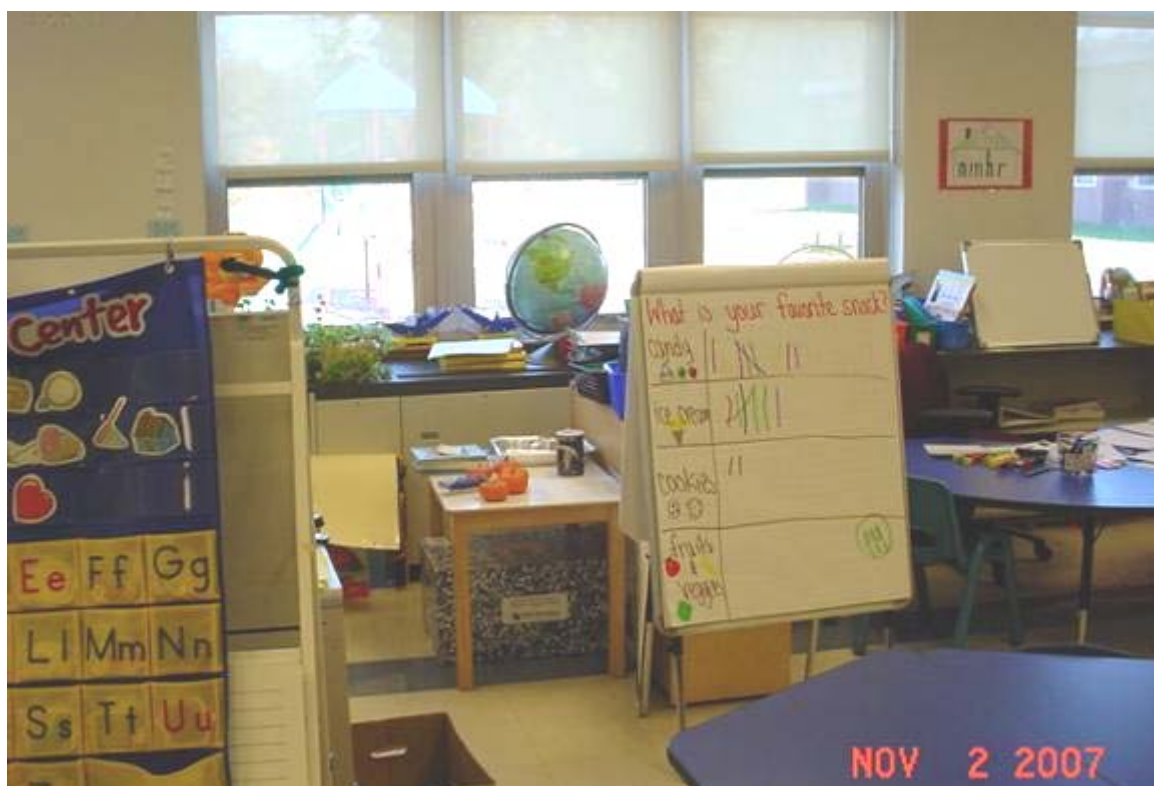
Picture 16

In a few classrooms, items were observed on windowsills, tabletops, counters, bookcases and desks (Pictures 3 and 16). The large number of items stored in classrooms provides a source for dusts to accumulate. These items (e.g., papers, folders, boxes) make it difficult for custodial staff to clean. Items should be relocated and/or be cleaned periodically to avoid excessive dust build up. In addition, these materials can accumulate on flat surfaces (e.g., desktops, shelving and carpets) in occupied areas and subsequently be re-aerosolized causing further irritation.

**Accumulated Items on Flat Surfaces in Classroom**

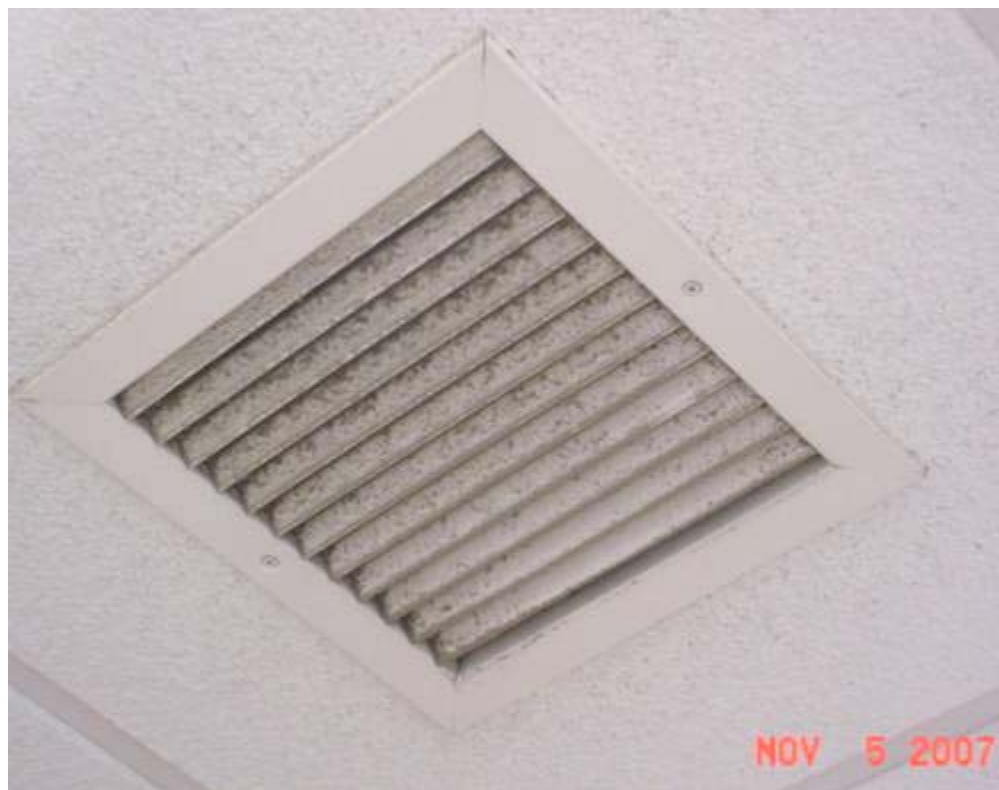
**Picture 17**

A number of univent air diffusers, supply vents, personal fans and exhaust/return vents were observed to have accumulated dust (Pictures 17 through 19). If exhaust vents are not functioning, backdrafting can occur, which can re-aerosolize accumulated dust particles. Re-activated univents and fans can also aerosolize dust accumulated on vents/fan blades. A hole was also observed in a ceiling tile in room 19, which can serve as a pathway for dirt, dust and debris that accumulates in the ceiling plenum into the classroom (Picture 20).

**Accumulated Dust/Debris on Return/Exhaust Vent**

14. Clean personal fans, univent air diffusers, return vents and exhaust vents periodically of accumulated dust. Particular attention should be paid in classroom 82.

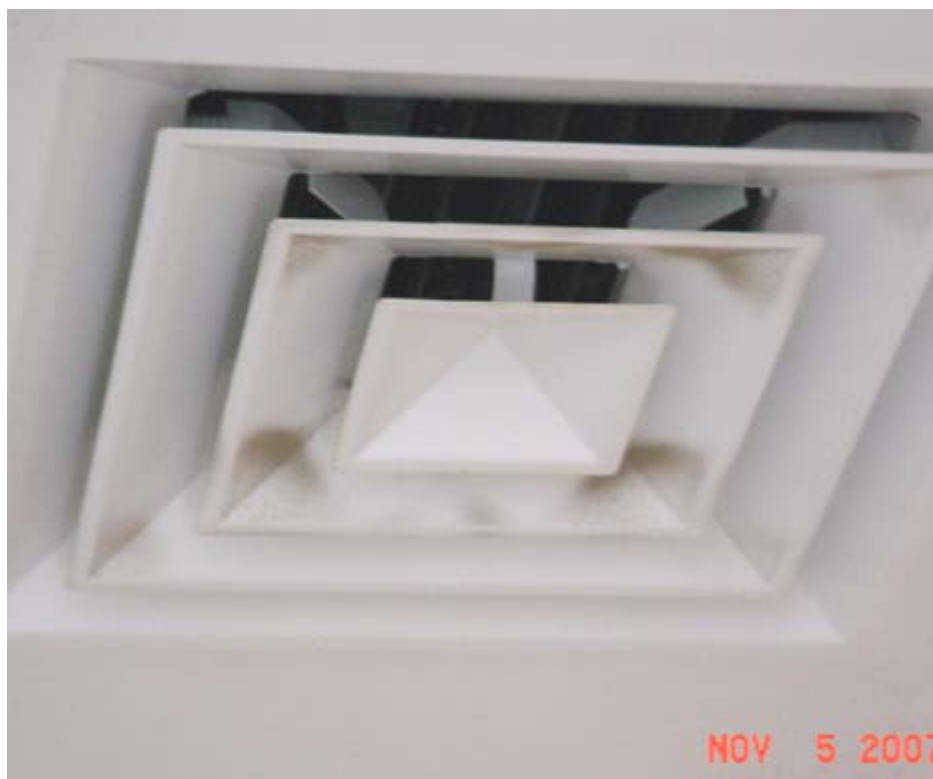
**Picture 18**

**Accumulated Dust/Debris on Supply Diffuser**

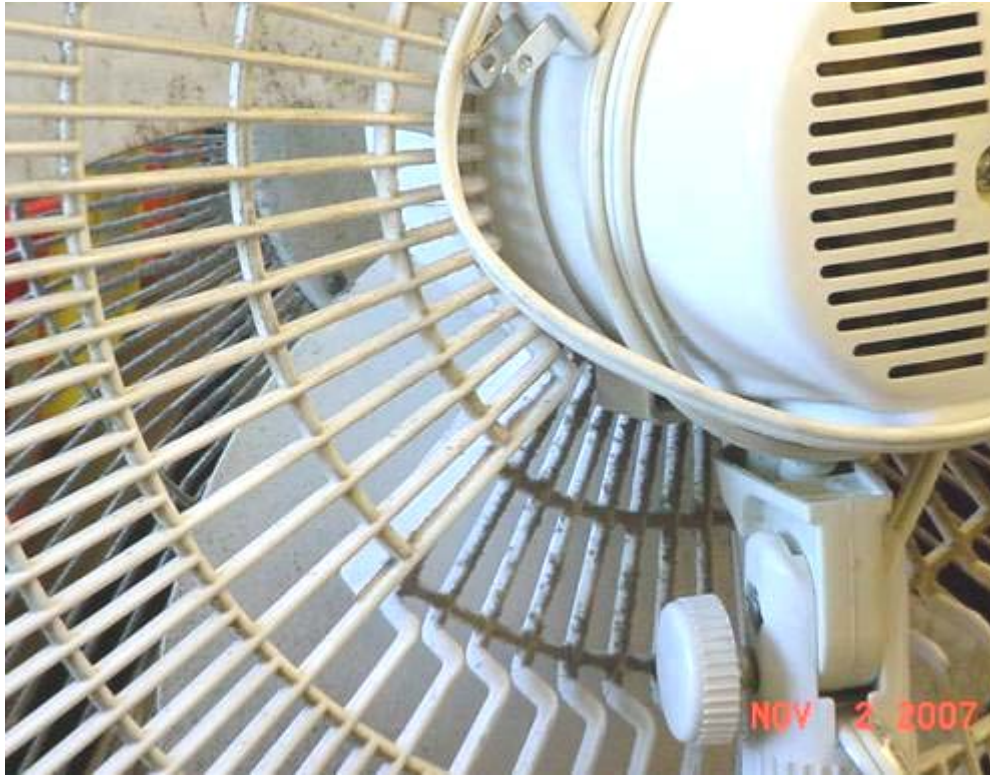
**Picture 19**

**Accumulated Dust/Debris on Personal Fan**

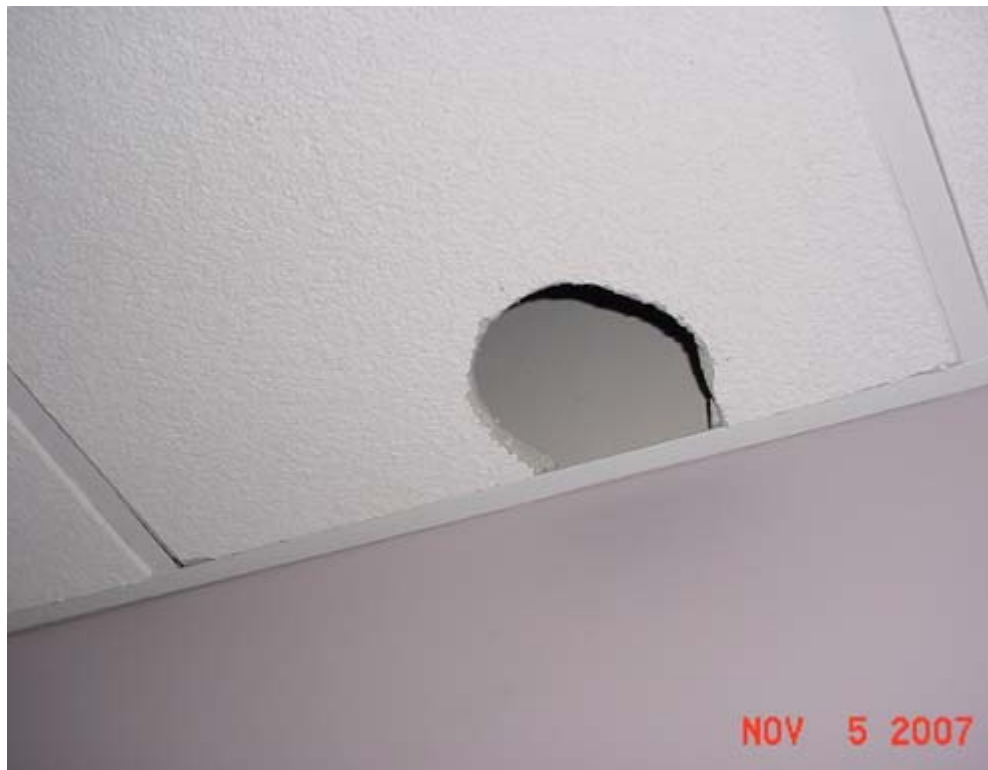
**Picture 20**

**Hole in Ceiling Tile in Room 19**

15. Replace damaged ceiling tile in classroom 19.
16. Clean/change filters for ACs as per the manufacture's instructions or more frequently if needed.
17. Install weather stripping underneath boiler room/hallway door to prevent the migration of odors and particulates.

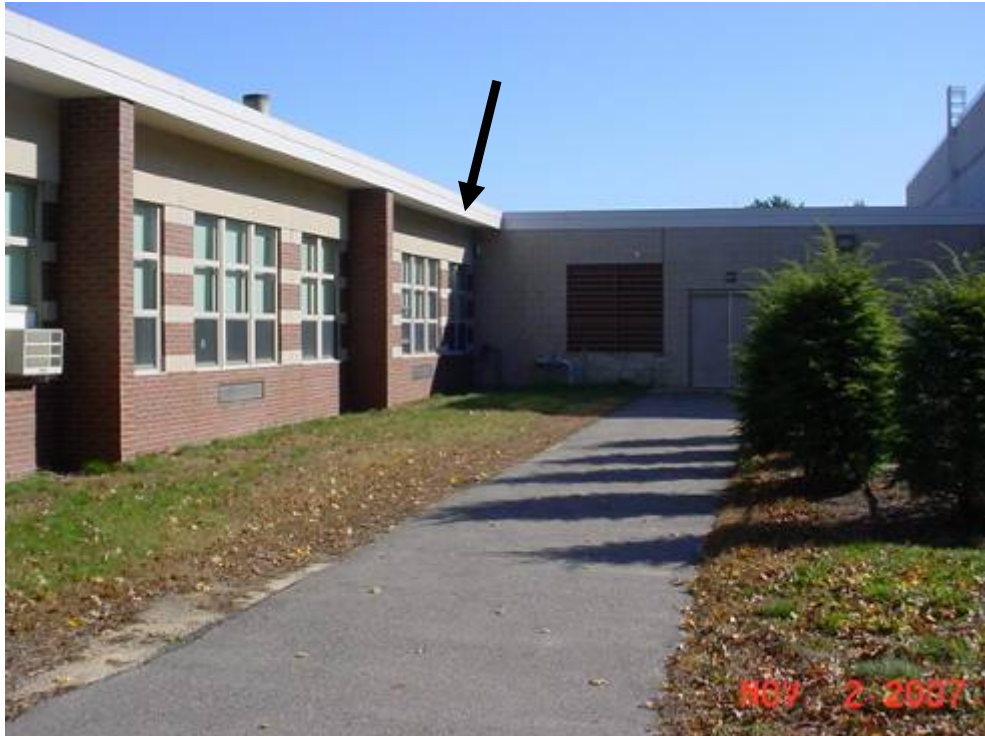
**Picture 21**

The occupant in classroom 82 had concerns of dirt/debris build-up on/around the univent. BEH staff examined the unit and its relationship to the exterior of the building. This classroom is located at the terminus of an alcove where two wings intersect outside the building (Picture 21). Loose dirt and plant debris was also observed below and accumulated on the univent fresh air intake outside the building (Pictures 22 and 23). BEH staff opened the univent cabinet to examine the interior and found similar accumulations of dirt and debris inside as to that outside (Picture 24). It is likely that dirt dust/debris accumulates in this area due to the configuration of the outside of the building, an alcove that can trap air currents and stir up loose dirt/debris, which can then be drawn into the classroom via the univent.

**Alcove Where Classroom 82 is Located**

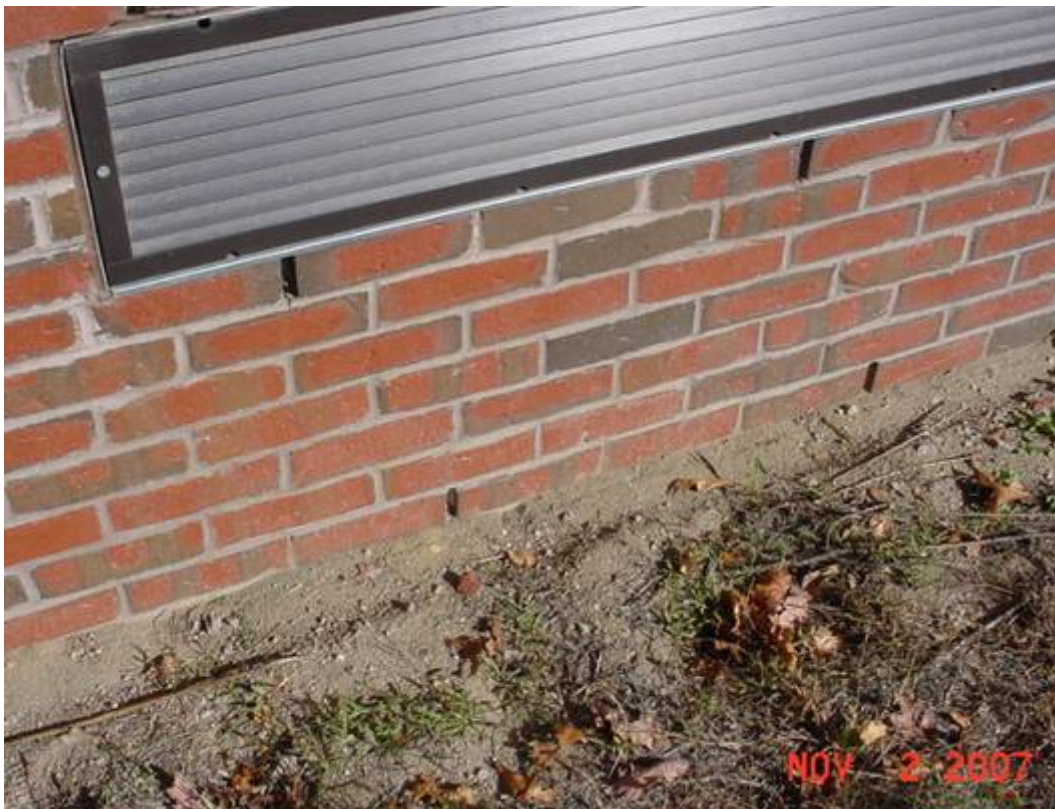
**Picture 22**

**Loose Dirt and Plant Debris beneath Univent Fresh Air Intake of Classroom 82**

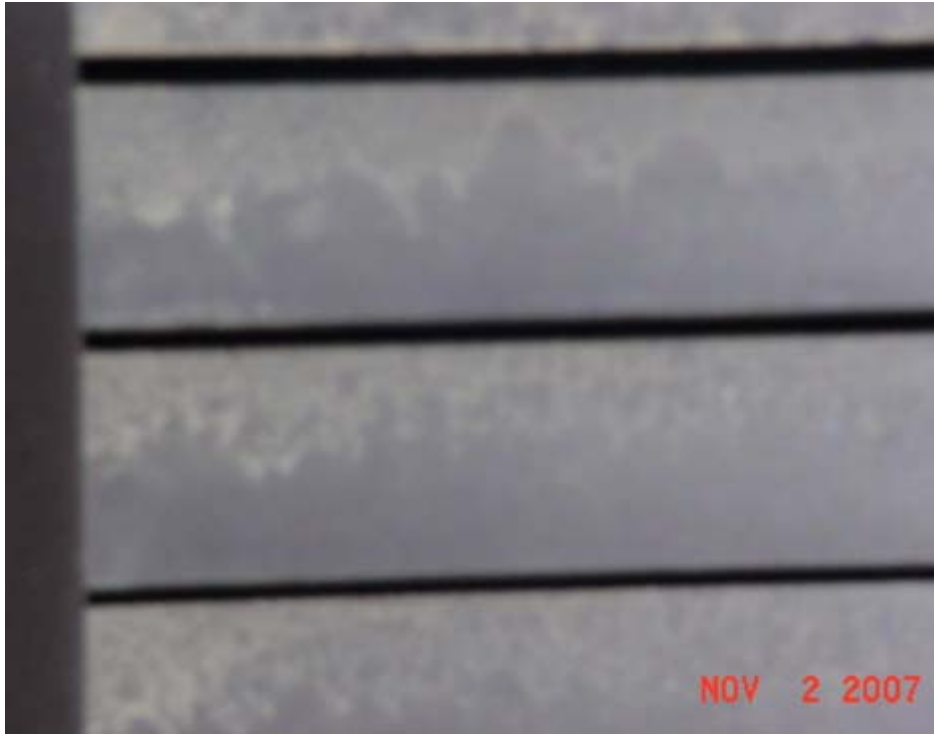
**Picture 23**

**Accumulated Dirt/Debris on Exterior Surface of Univent Fresh Air Intake of Classroom 82**

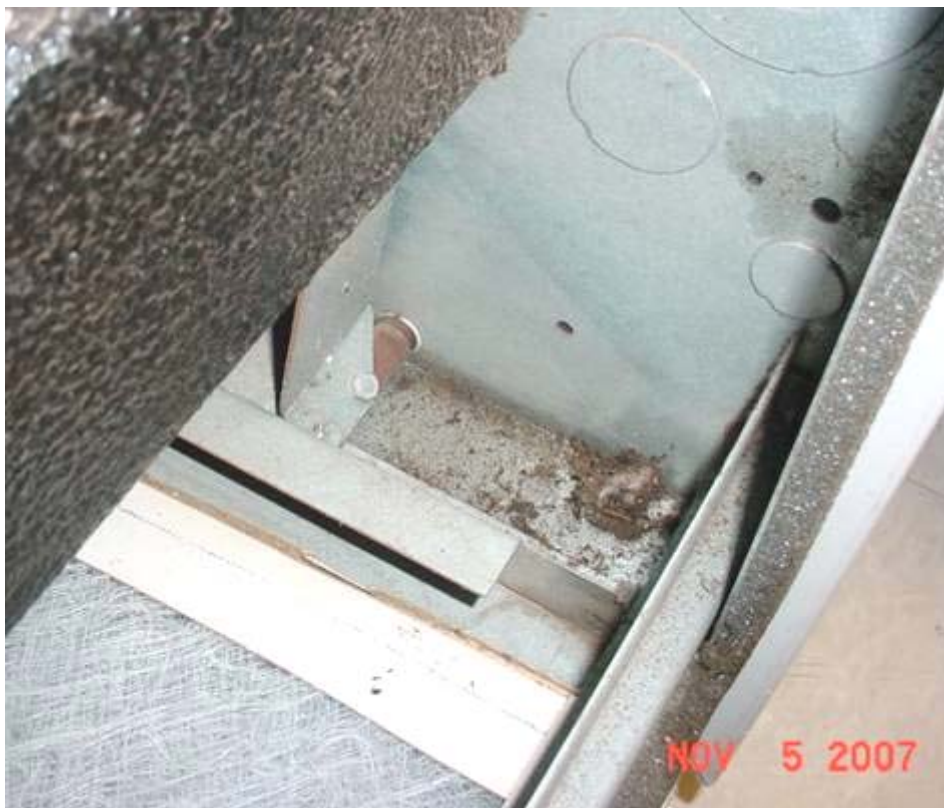
**Picture 24**

**Accumulated Dirt/Debris inside Cabinet of Univent in Classroom 82**

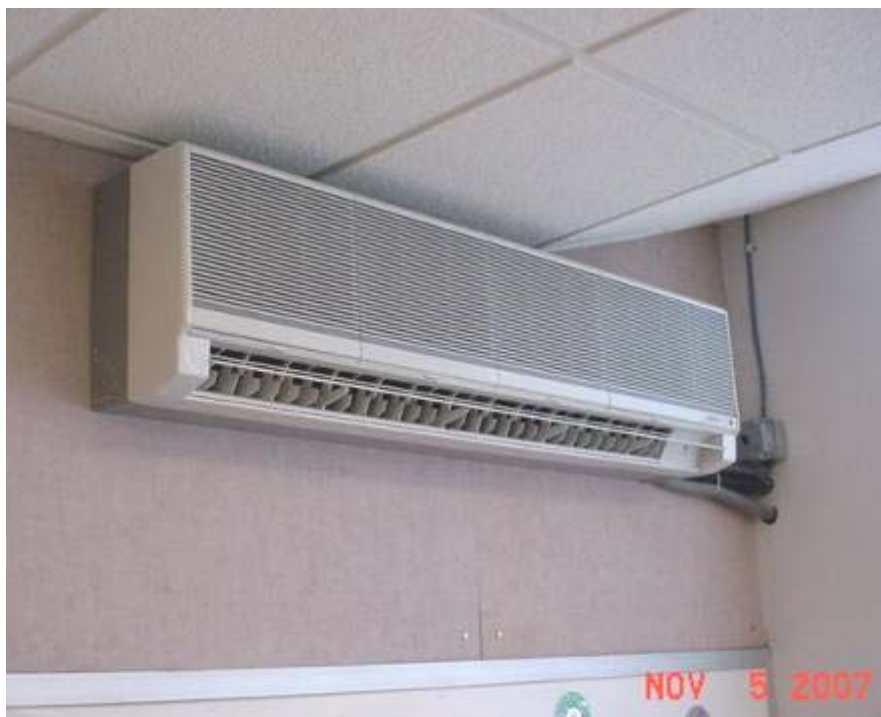
**Picture 25**

A number of classrooms had window-mounted air conditioners (ACs) or wall-mounted units (Picture 25). ACs are normally equipped with filters, which should be cleaned or changed as per manufacturer's instructions to avoid the build-up and re-aerosolization of dirt, dust and particulate matter.

**Wall-Mounted AC Unit**

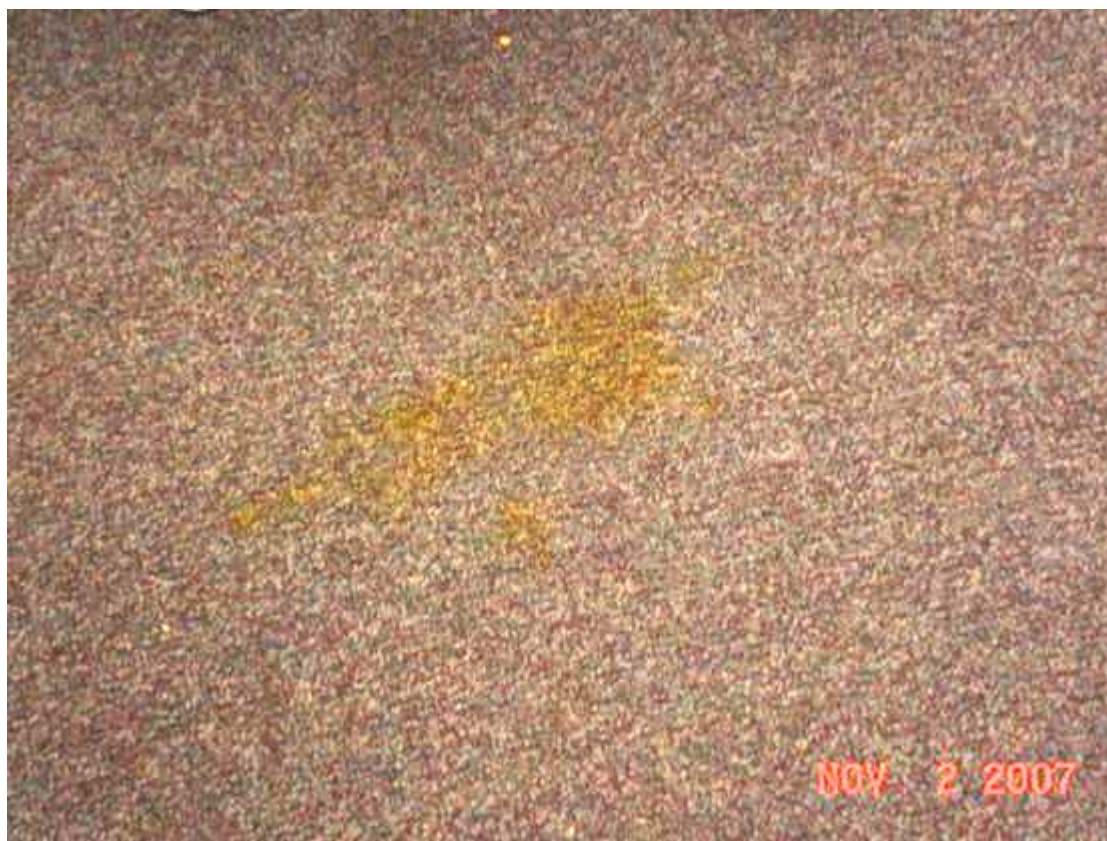
**Picture 26**

Finally, occupants reported concern regarding the condition of carpeting in classroom 75. According to an occupant, the carpet had become soiled from bodily fluids (i.e., excrement). Although the carpet was reportedly cleaned at the time of the assessment the carpet was visibly soiled/stained (Picture 26). The Institute of Inspection, Cleaning and Restoration Certification (IICRC), who provide guidance concerning professional restoration of water damaged materials, any porous materials damaged by category 3 water (also known as "black" water) should be removed. Category 3 water is defined as grossly unsanitary water containing pathogenic agents arising from sewage or similar contaminated water sources (IICRC, 1999).

## **Soiled Carpeting in Classroom 75**

19. Replace soiled portion of carpeting in classroom 75 in accordance with recommendations by the Institute of Inspection, Cleaning and Restoration Certification (IICRC, 1999).
